NATIONAL ADVISORY COMMITTEE FOR AERONAUTICS

June 1944 as
Restricted Bulletin 4F06

AN INVESTIGATION OF THE CHARACTERISTICS OF A
PROPELLER ALCOHOL FEED RING

By Carr B. Neel, Jr.

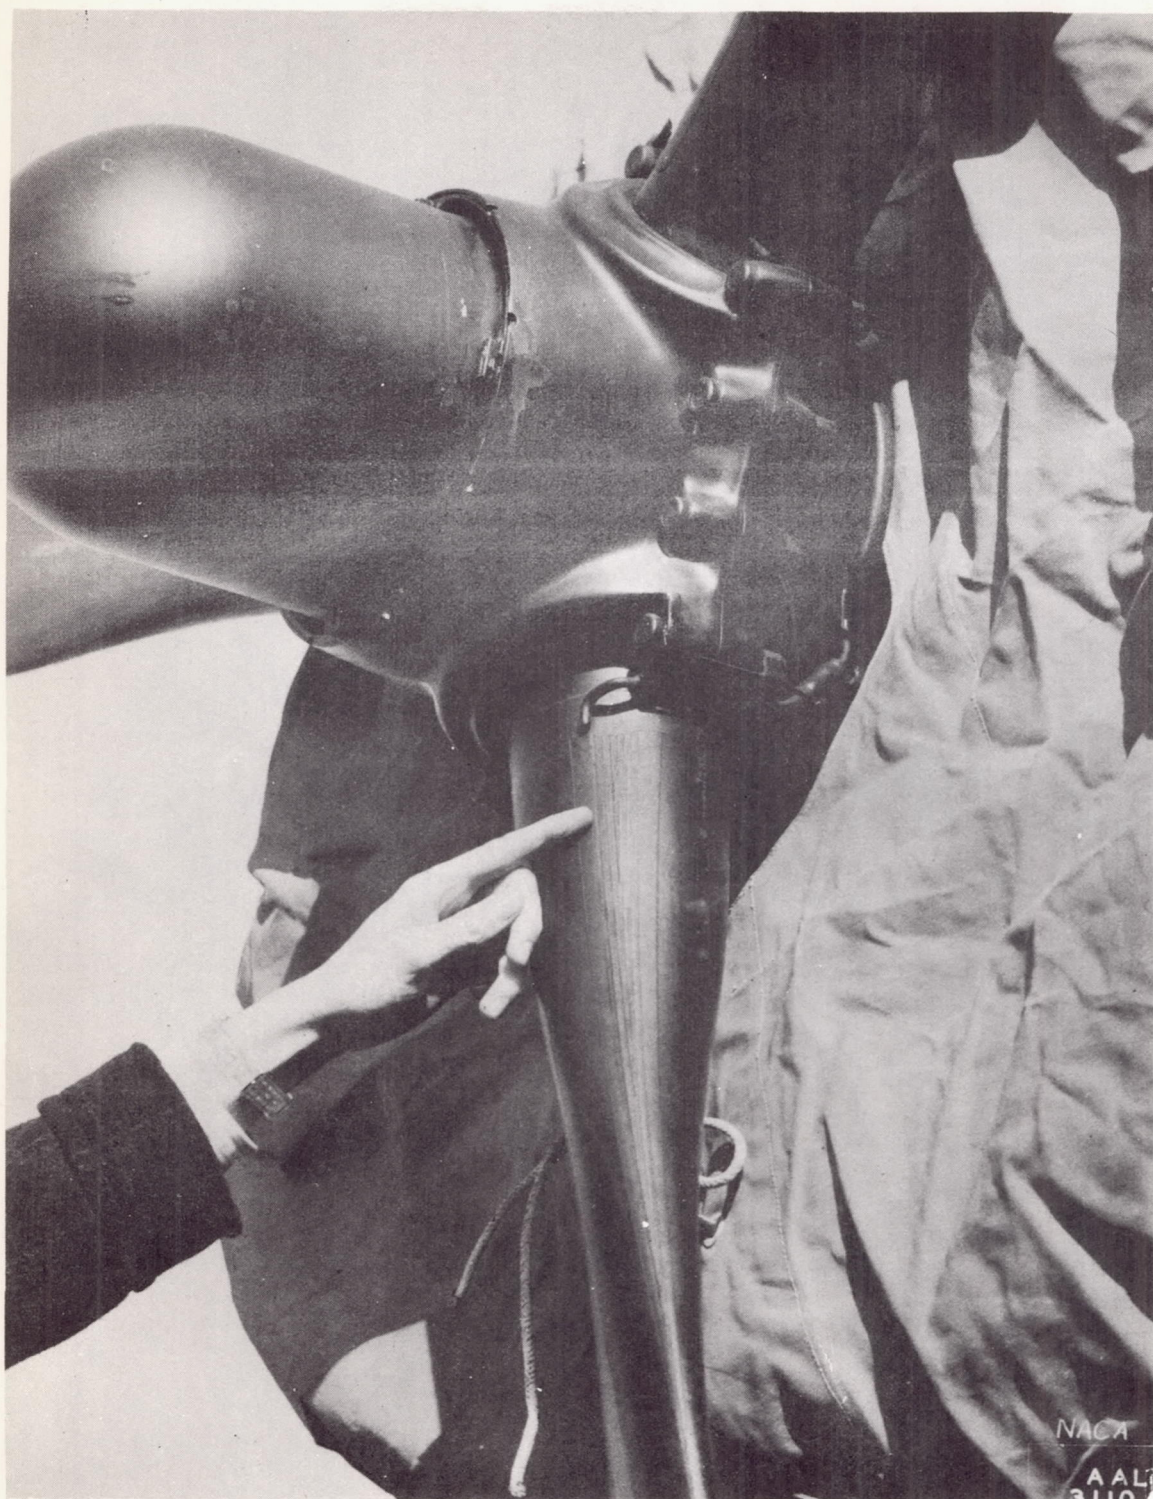
Figure 2.- A typical propeller alcohol-discharge-nozzle installation.

The standard propeller alcohol system with the discharge nozzle consists of a small metal tube mounted on the propeller hub at the root of each blade. The nozzle is adjusted to discharge fluid into the grooves of the propeller anti-icing feed shoe. Alcohol is supplied from

a slinger-ring assembly to the discharge nozzles. A discharge-nozzle arrangement, similar to the one tested on the C-46 airplane, is shown in figure 2.
